ePIPE® Stops Water Loss in London area Swimming Pool – Puts Owners Back into the Swim

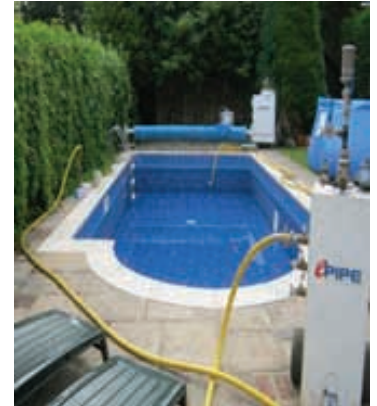
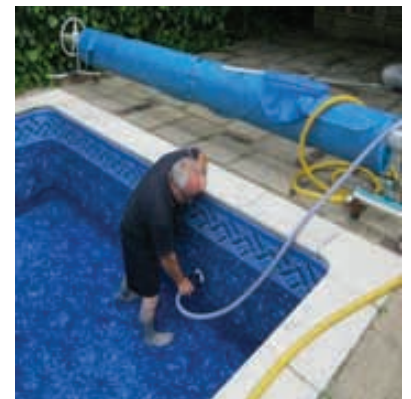
With an estimated water loss of 3500 litres per day through leaking pipes, the cost of maintaining the pool was forcing the owner to shut it down during one of the hottest English summers on record. Even worse the traditional dig and fix option was uneconomical and would have resulted in the pool still being out of service well into the autumn.

- 1) Pressure tests identified leaks on the skimmer and return pipes.
- 2) Isolation of the leaking pipes.
- 3) Drain, dry and prepare the pipe work for the ePIPE barrier /leak sealant coating.
- 4) Application of the barrier/leak sealant coating into each pipe section.
- 5) After a short curing process of 2 hours, a pressure test was applied.

Result: no loss of pressure, leaks sealed.

Pipe Restoration Services were tasked with repairing the leaking pipes, in-place using ePIPE's patented technology.

This project was completed in a 1½ days, no excavations required.
