ePIPE - First in UK

Lining of Communication and Supply Lead Drinking Water Pipes

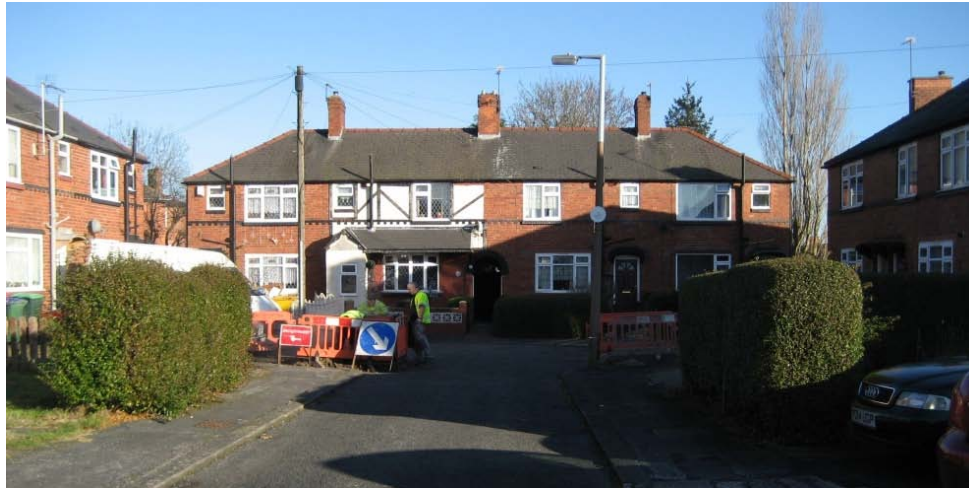
The advantage of the ePIPE process over other methods for replacement or remediation is the ability to apply the approved coating to the insides of pipes having common connections and to minimize digging up the pipes on the customers property or to dig up across the roadway to lay a new communication pipe.

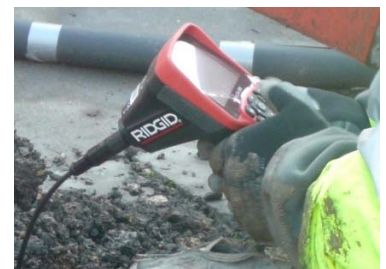
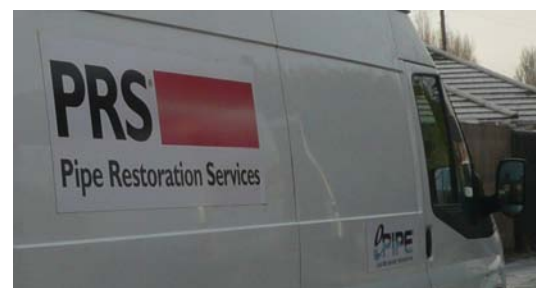
Pipes were heated, drained and prepared for the coating. At least 2 undisclosed customer side leaks were identified and were repaired during the lining process. The coating process was broken into 2 primary segments...

- 1) Long side 3/4" ID lead communication pipe, under the road, length about 7.5M
- 2) Common supply 1/2" ID lead pipes with single section lengths up to about 11m.

The pipes were then coated and cured in the 2 hour time frame. Inspection took place using a micro camera and water was then restored.

Starting daytime temperatures were about -7C and never rose above freezing for the day.
