A Pipe Repair Alternative

BY AMANDA STROUSE

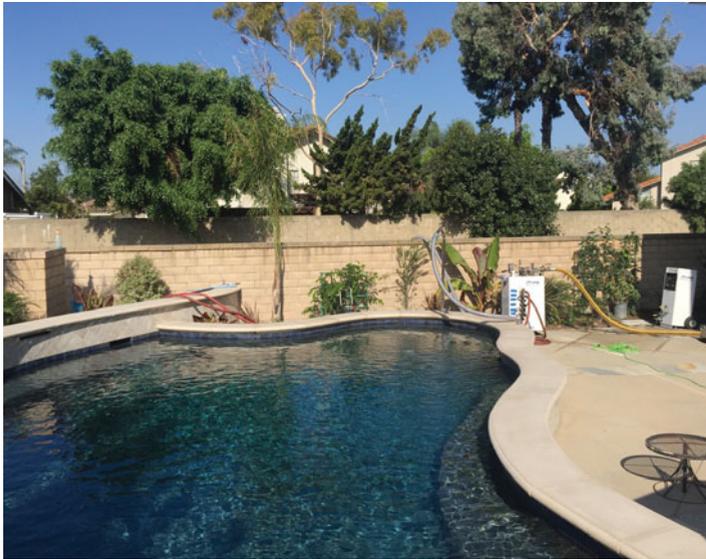
Leaky pool plumbing under this water cannon (see right) was renewed using a blown through epoxy process instead of jackhammering.

One example is Tri Cities Pools, an established pool service and repair company in Brea, California, that was recently contacted by a homeowner who was experiencing a water piping problem with his pool's water feature (a stainless steel water cannon). Water leaked out the side of the pool wall and the concrete deck whenever the water feature was in operation.

the chance of damaging the pool wall, coping or plaster. Shaw instead chose to go with epoxy coating technology from Pipe Restoration, Inc. The process, known as ePIPE, applied an NSF 61 approved resin that cures in 90 minutes, so the project could be completed in just one day.

First, the certified ePIPE team drained the pool lines to be worked on and hooked up an air compressor to the pool pump's existing piping system. Next, clean hot air from the compressor was blown through the 2-inch wide plastic piping to the water cannon, drying it. Then an abrasive agent was blown through those same pipes to clean them and prep them for epoxy adhesion. Finally, liquid epoxy was blown through the pipes, from the pool pump to the cannons. Once the epoxy cured, a protective barrier coating had formed, closing off leaks and preventing further leaks from occurring.

Using ePIPE, the project was completed in just five hours. If a traditional repair (jackhammering) was chosen, the project was estimated to have taken several days.
